SUCCESS CASE

# INLINE LEAK DETECTION IN A NEWLY CONSTRUCTED TRANSMISSION MAIN

Navajo Nation, New Mexico, USA

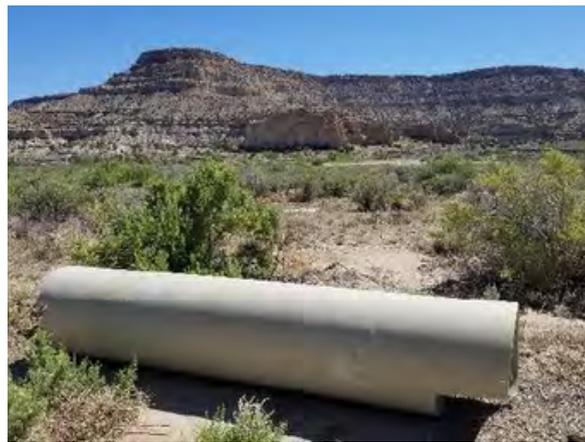
*Pipeline in New Mexico, USA*

Pipeline	Characteristics
Location	Navajo Nation, New Mexico, USA
Pipeline material	Fiberglass
Diameter	600 mm (24")
Water speed	0.5 m/s
Pressure	0 – 13 bar
Insertion point	DN150 valve (vertical access)
Extraction point	Regulation point with catch net and camera monitoring

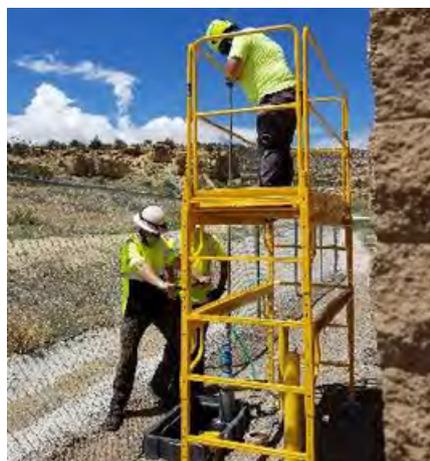
*Nautilus insertion*

- Insertion & extraction: Via 150 mm valve and regulation point.
- North section: 10.6 km inspected in 5h 58m with 13 synchronizers.
- South section: 14.7 km inspected in 8h 31m with 15 synchronizers.
- Flow interruptions: Pump failures were handled effectively, and data analysis was successfully adapted.

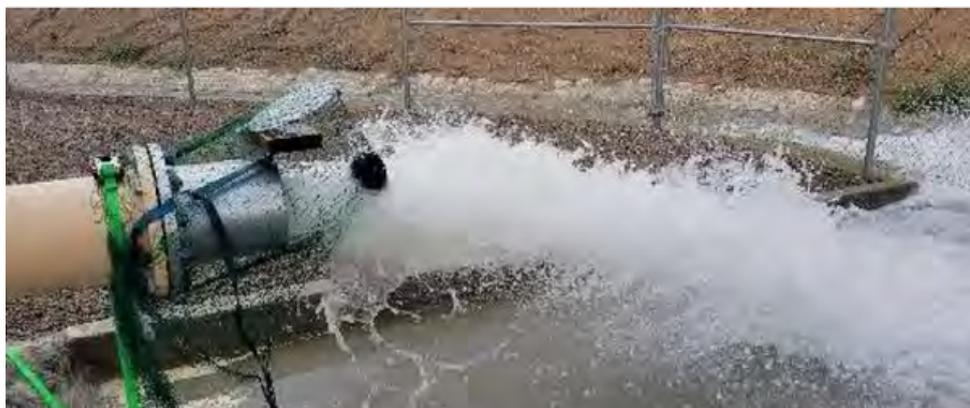
*Controlled Water Discharge During Nautilus Extraction*
